Survey No. AA859

Maryland Historical Trust State Historic Sites Inventory Form

1. Nam	le (indicate pr	referred name)		
historic W	ATKINS/WELSH WING			
and/or common	WATKINS/WELSH	SCHOOLHOUSE		
2. Loca	ation			
street & number	DAVIDSONVI	LLE ROAD		not for publication
city, town	DAVIDSONVILLE	vicinity of	_{1է} բongressional district	
state	MARYLAND	county	ANNE ARUNDEL	co.

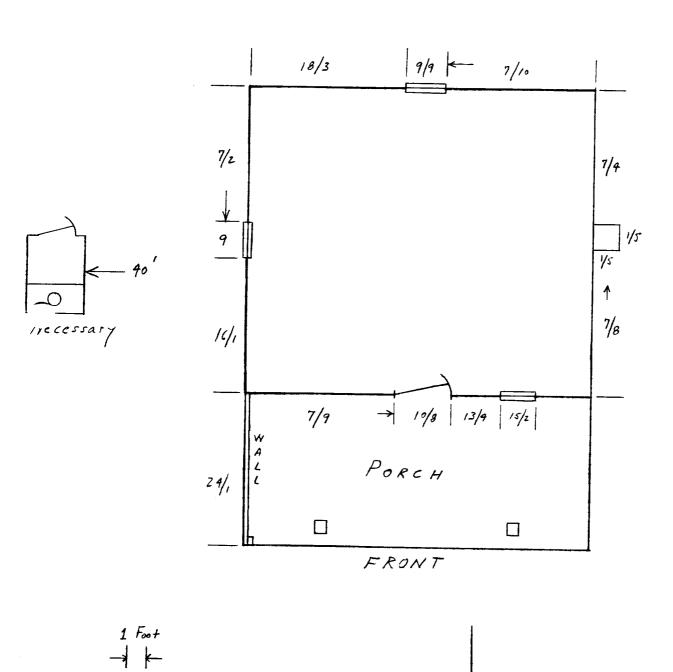
South

This one and half story building has a gable roof which has been extended on the front to cover a full width porch. Closer inspection reveals that a narrowerer centered porch roof still remains under the newer roof. The original two square posts of this earlier roof supports the current roof with another one at the west end. The west side has been enclosed. The floor is concrete. A front entrance is centered. Its door has six panes over a single panel. To the right is a narrow vertical single pane window.
